**Eagle Picher
Ohio, Michigan, and Illinois Properties
TDD: S05-0603-003**

Site Inspection Reports

**Subject: Site Inspection Reports
Eagle Picher Ohio/Michigan/Illinois Properties
Technical Direction Document No. S05-0603-003
Tetra Tech Contract No. 68-W-00-129**

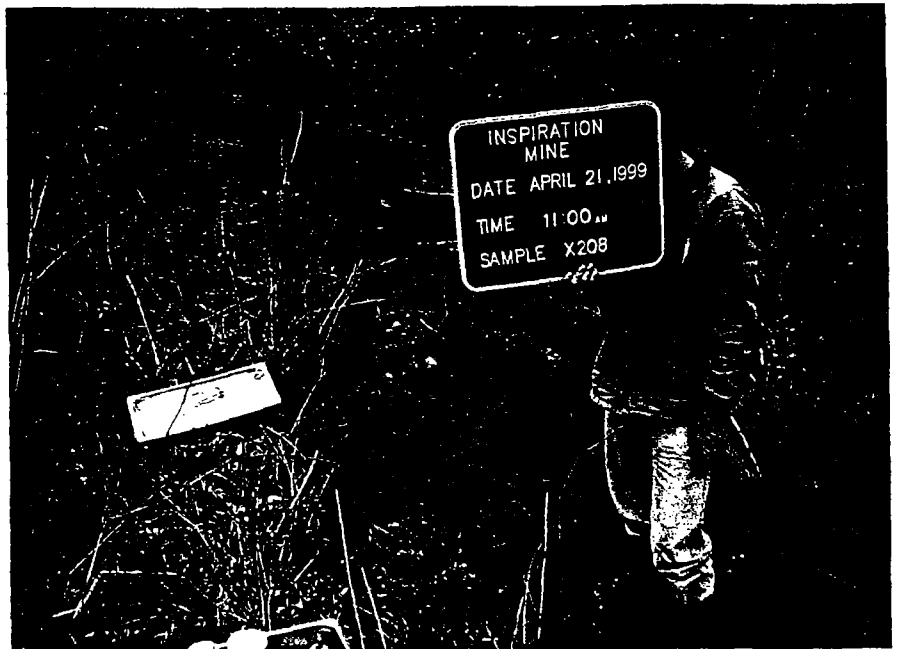
COMMENTS: Photo taken
of sediment sample
in Millbrig Hollow.

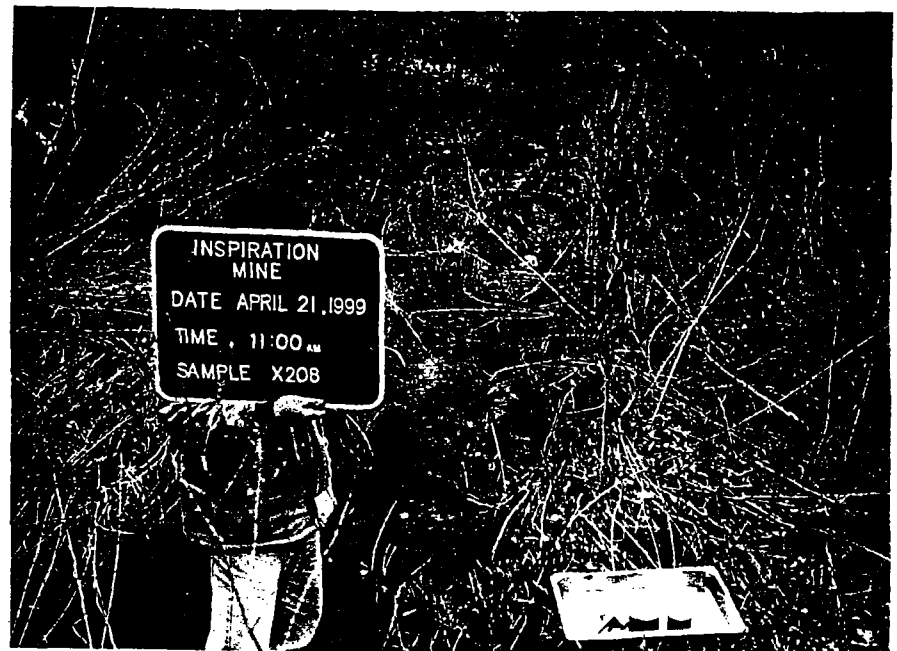
COMMENTS: Photo taken
of sediment sample in
Millbrig Hollow.

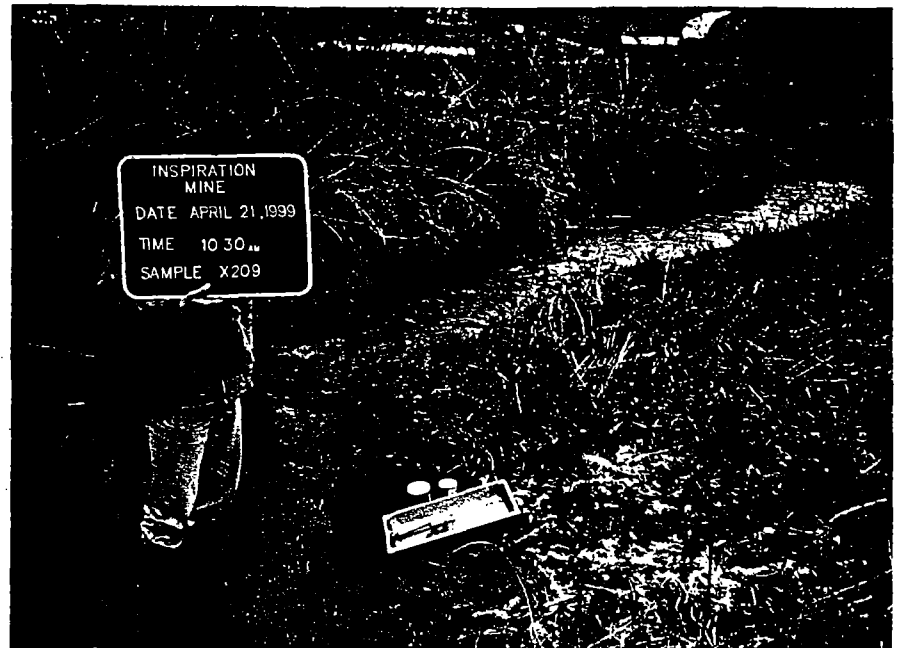
COMMENTS: Photo taken of sediment sample in Millbrig Hollow 120 feet west of the Galena River.

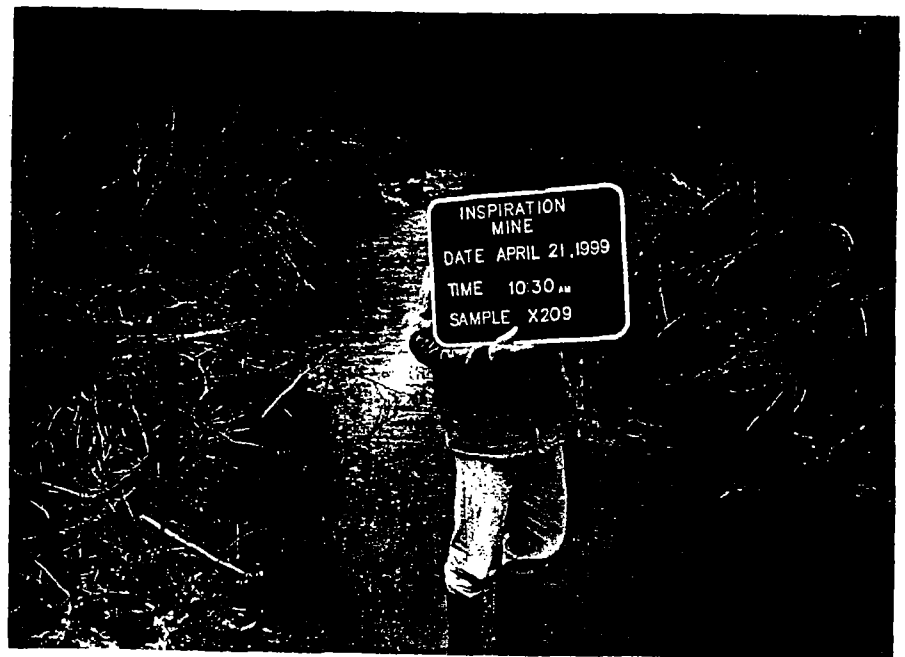
COMMENTS: Photo taken of sediment sample in Millbrig Hollow 120 feet west of the Galena River.

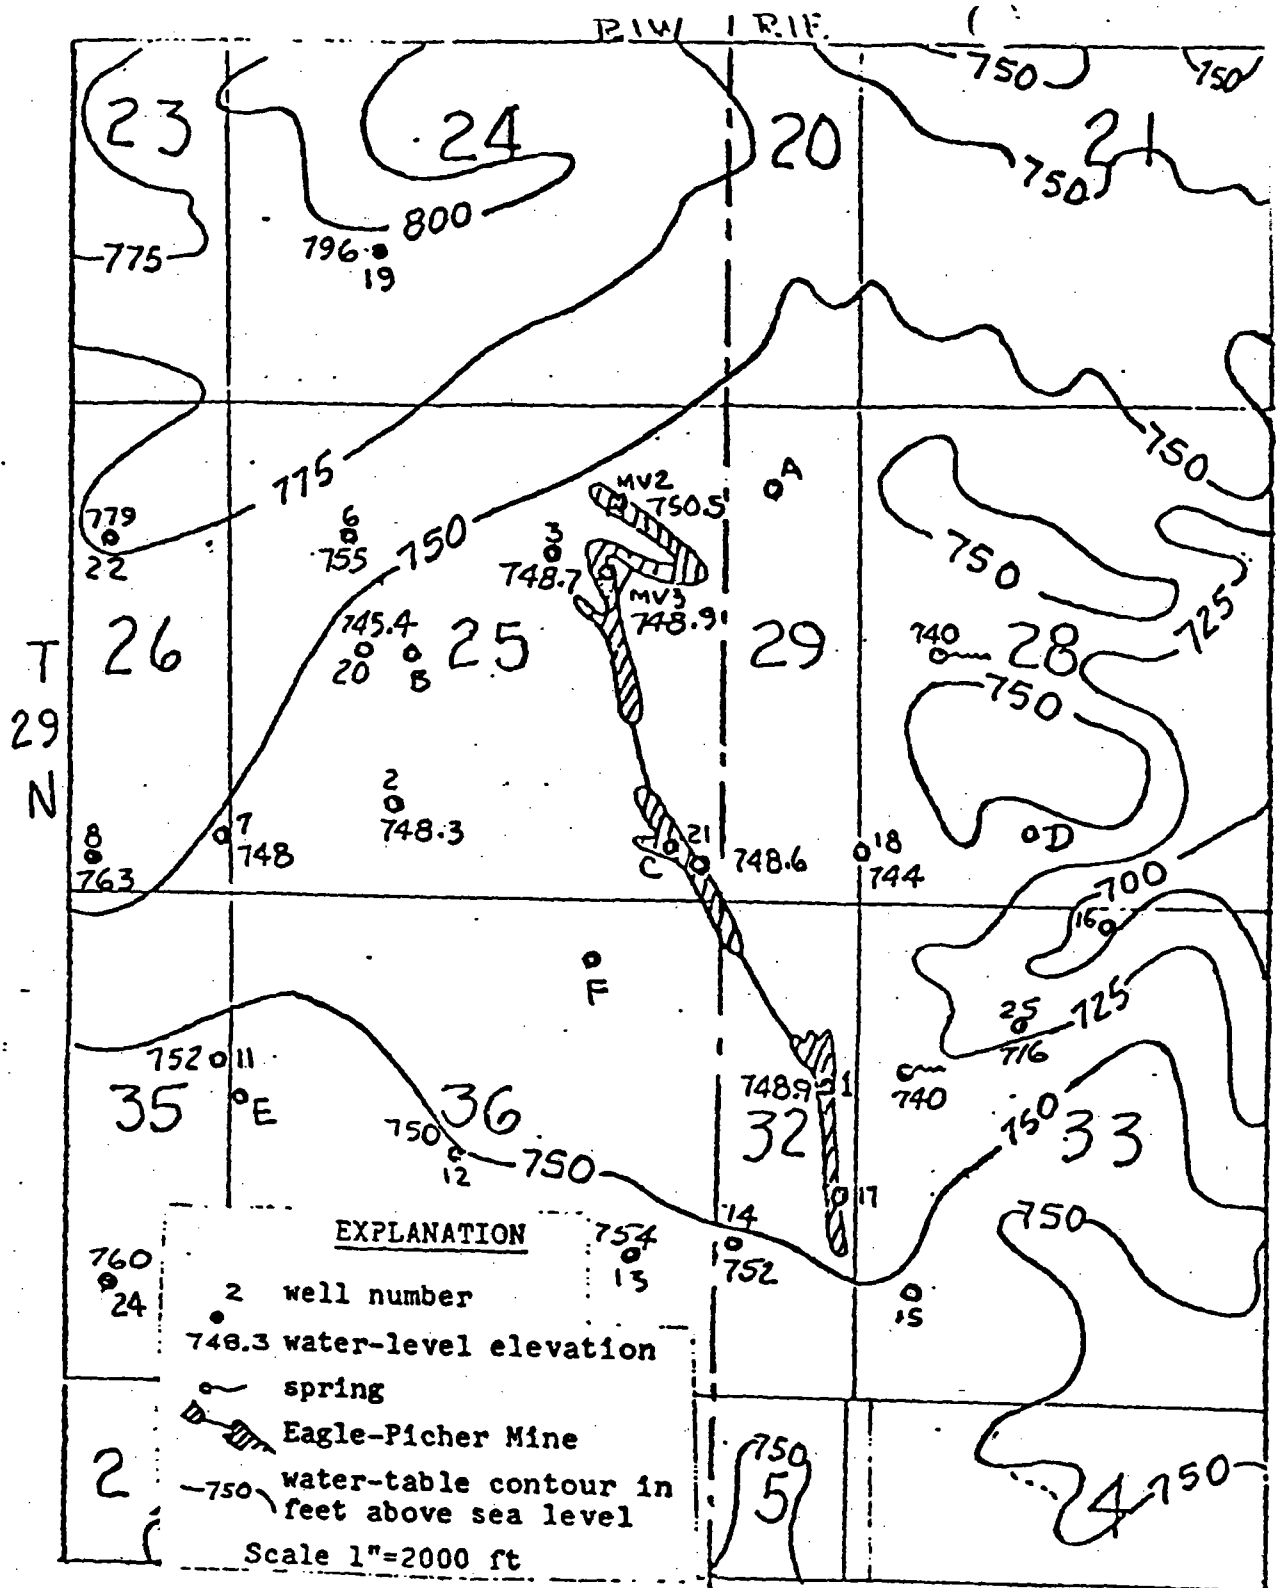
Figure 3. Approximate elevation of water table - July 1968

From figure 3 it is evident that a hydraulic gradient from the mine toward the west and east existed during the middle part of July. Although the gradient was only a matter of a few tenths of a foot within the critical area of adverse groundwater quality change, there nevertheless was a "downhill" slope from the mine toward every one of the wells which had been shown by chemical analyses to have been affected. This is especially significant when it is considered that geologic and hydrologic studies have shown the major solution cracks in the aquifer to be east-west oriented, and that water levels declined in all of these wells during the mine-dewatering operation. These facts tend to prove an interconnection of the solution cracks tapped by the wells and the mine-opening system.

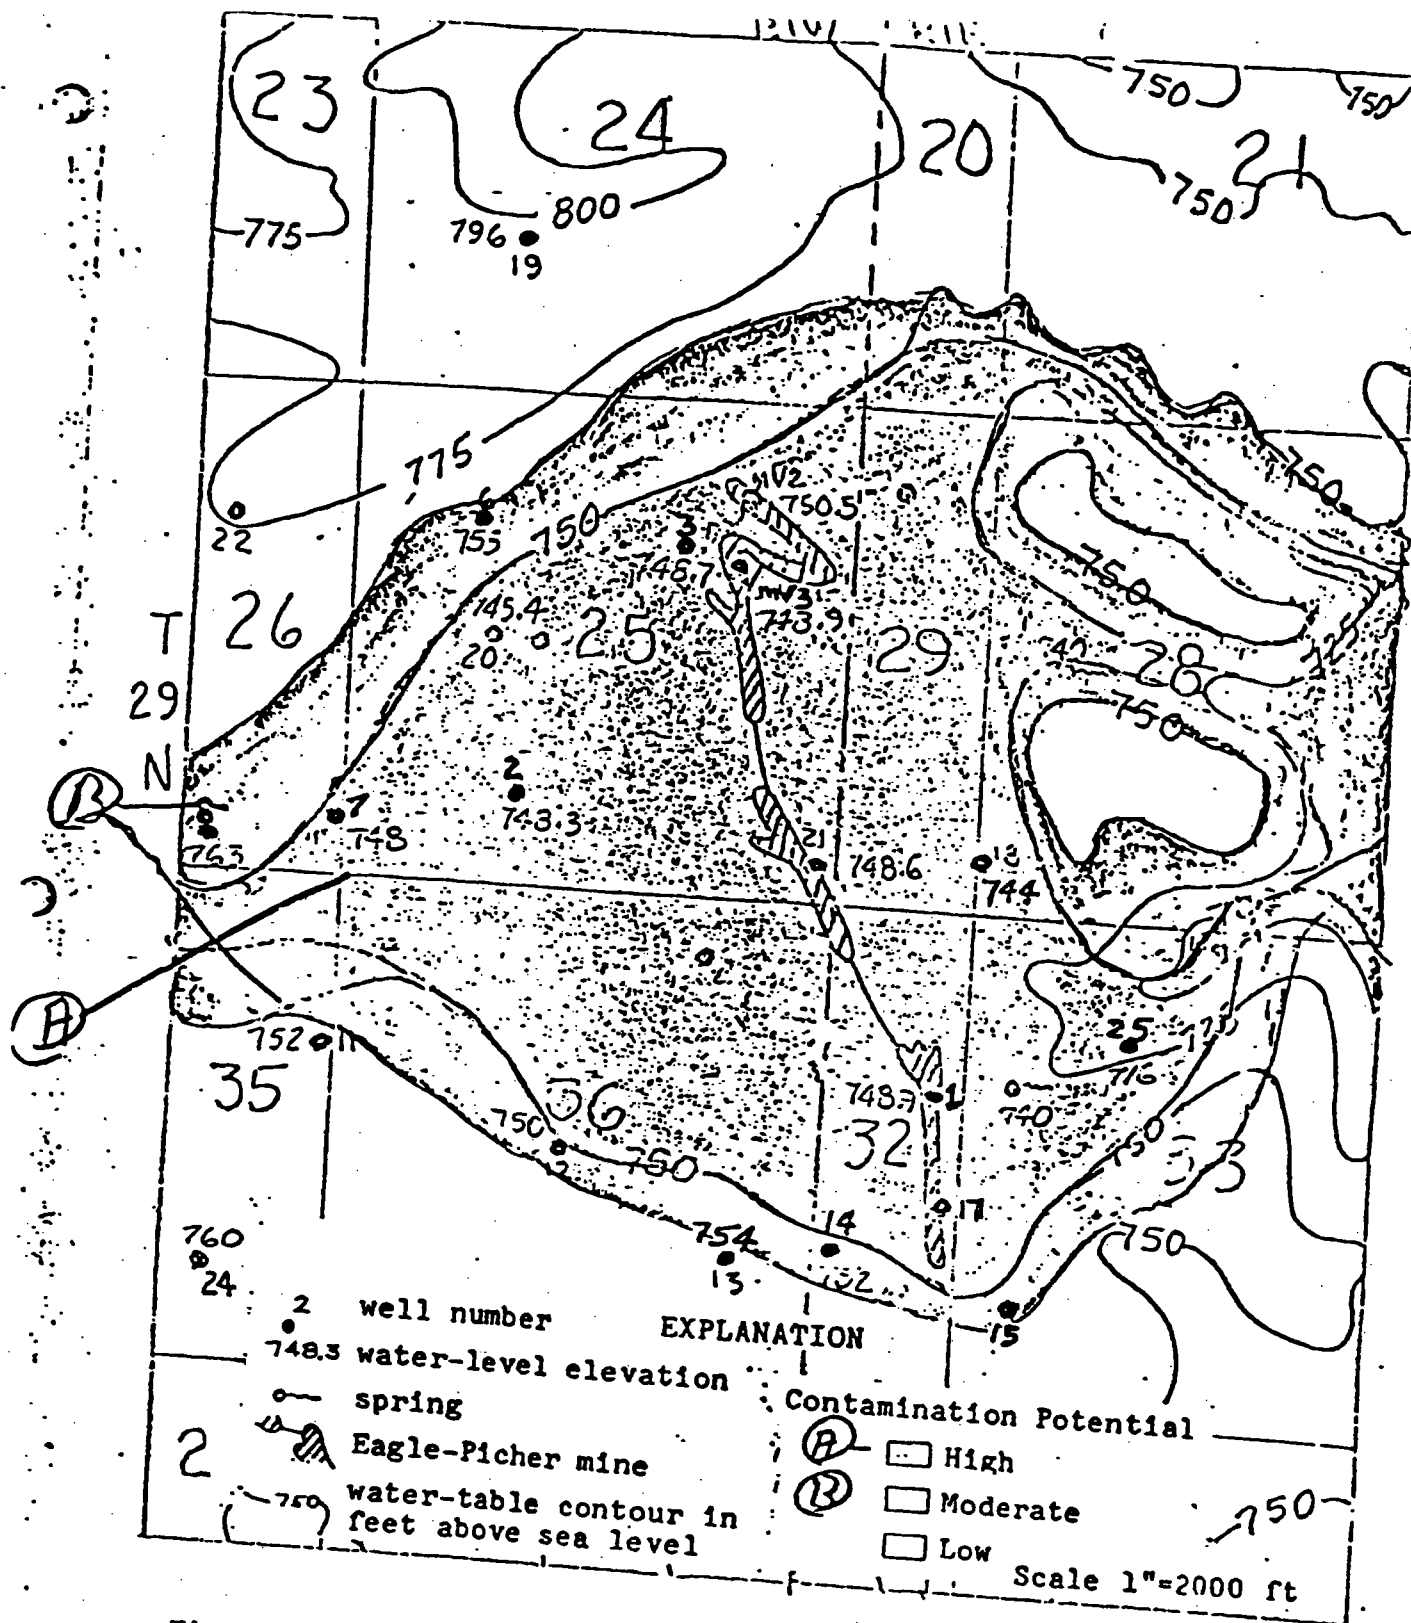
Figure 5. Water level-contamination potential relationship in vicinity of Eagle-Picher Mine operation

Based on available water-level and chemical data, and long proven and accepted geohydrologic principals of groundwater occurrence and movement, the water level-contamination potential relationship map shown in figure 5 was constructed. In this interpretation the assumption was made that the water table would continue to effectively rise or fall as a unit in the future in response to recharge from precipitation, and that the relative position of the zone of contamination hazard would remain fairly fixed in shape and extent until the pre-mining water table illustrated in figure 2 was again realized at some time in the future. Once this has happened, the general direction of groundwater flow from the area of the mine should be to the east toward the Galena River. However, in July of 1968 the groundwater gradient was both west and east as is shown in figure 3. Although the gradients prior to that time during the

This has not been the case for the mine operation investigation made in 1968, however. All of the analyses (Appendix C) of water from wells near the mine that are within the high contamination potential area delineated using water-level data (see figure 5) show deterioration of normal water chemical quality. Also, some of the analyses revealed chemical constituents such as cyanide which are common to the ore process operation in question, but which are not normally present in natural groundwaters of this area.

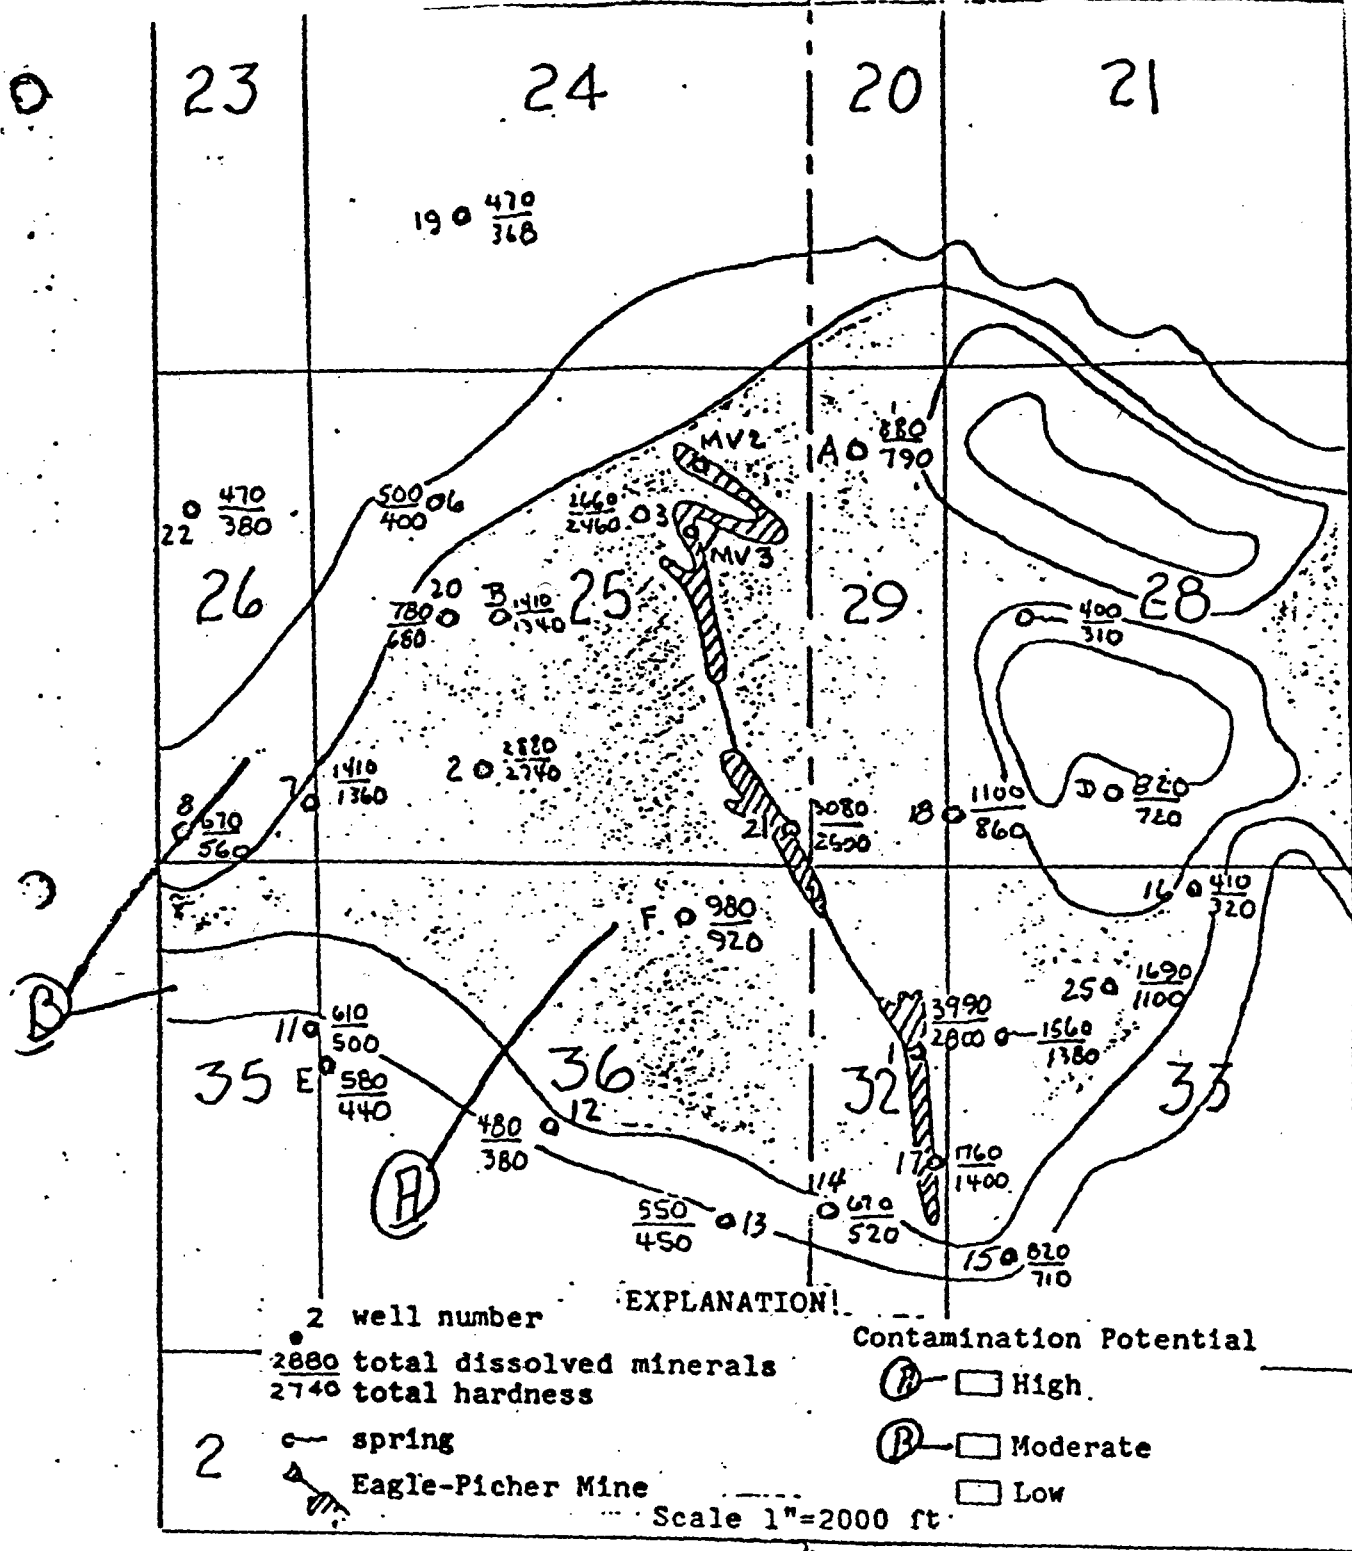
Figure 6. Chemical quality-contamination potential relationship in vicinity of Eagle-Picher Mine operation

Using available chemical analyses of groundwater samples collected from wells within the area, from the mine in question, and from the ore-process waste water being discharged into that mine, a chemical quality-contamination potential relationship was established which coincides with the contamination relationship obtained from the water-level part of the study. This relationship is given in figure 6. Near the edges of the study area, in locations where maximum dilution from uncontaminated groundwater from unaffected parts of the aquifer occurs, or in areas of weak geochemical control, there are a few questionable data points. It is probable that detailed future studies in these localized areas could further refine these interpretations.

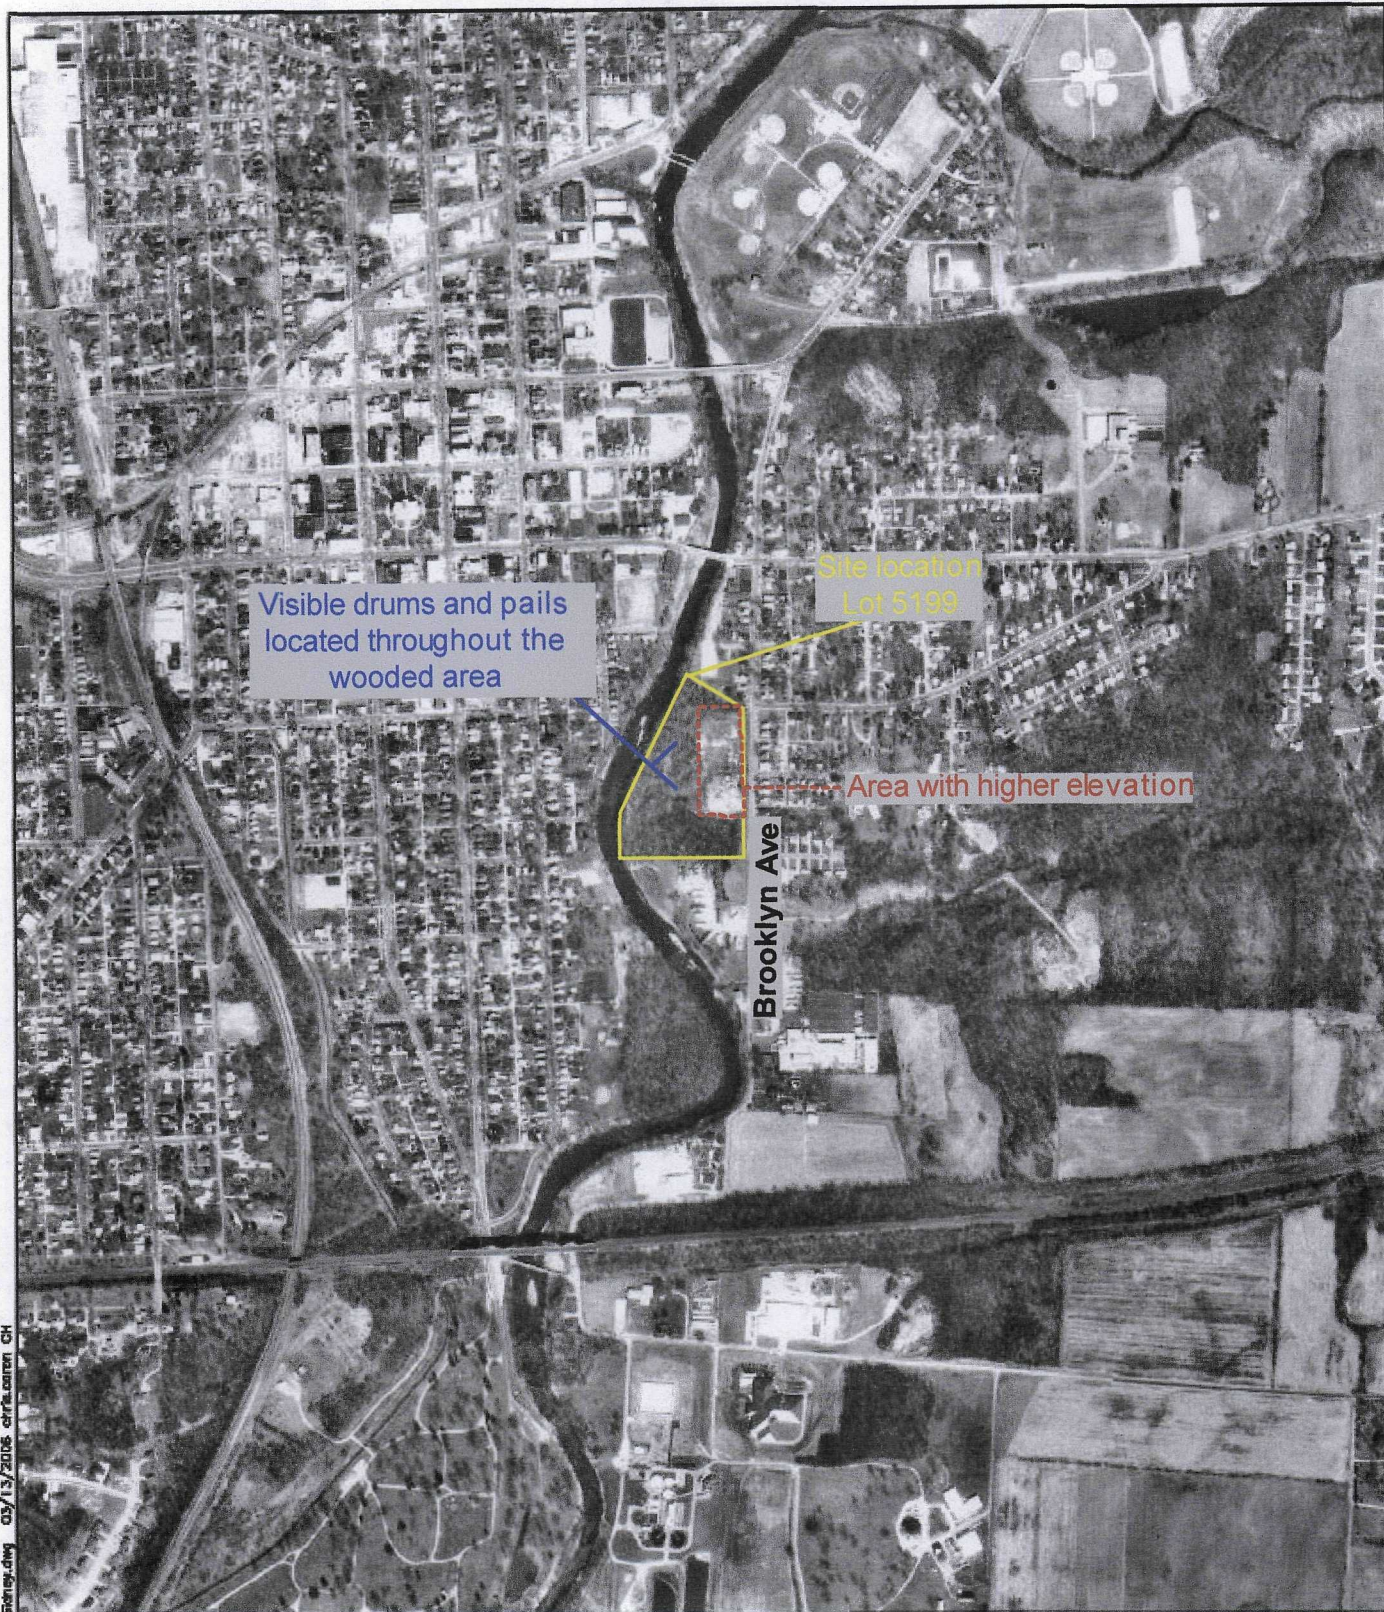
Visible drums and pails
located throughout the
wooded area

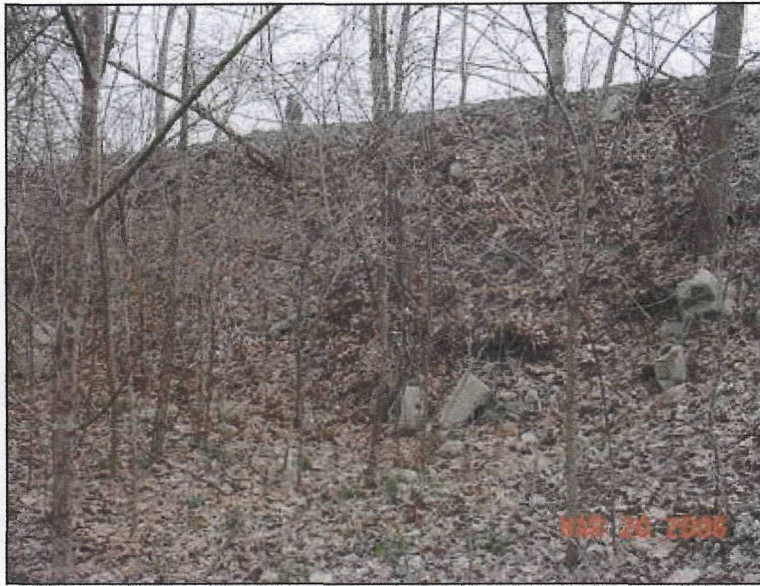
Photograph No. 1 **Date:** March 20, 2006
TDD No.: S05-0603-003 **Orientation:** East
Location: Lot 5199 Brooklyn Avenue, Sidney, Ohio
Subject: Up the slope from the lower portion of the property.

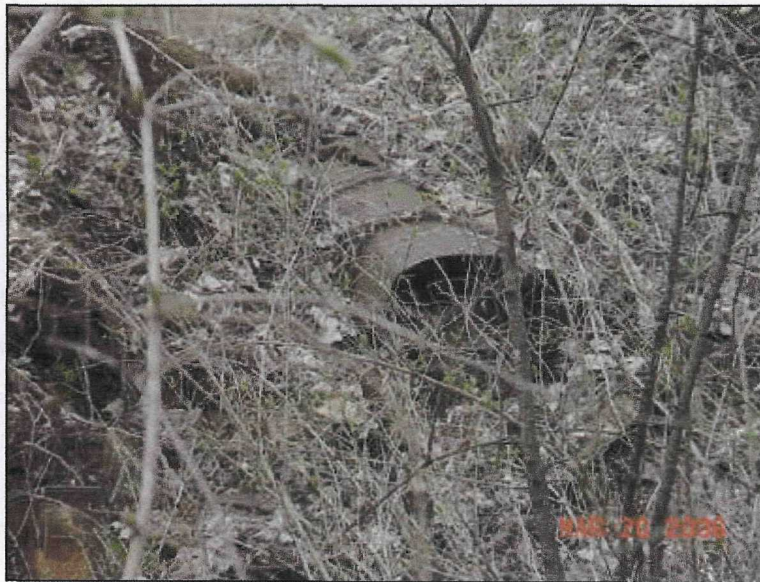
Photograph No. 2 **Date:** March 20, 2006
TDD No.: S05-0603-003 **Orientation:** West
Location: Lot 5199 Brooklyn Avenue, Sidney, Ohio
Subject: Partially buried drum

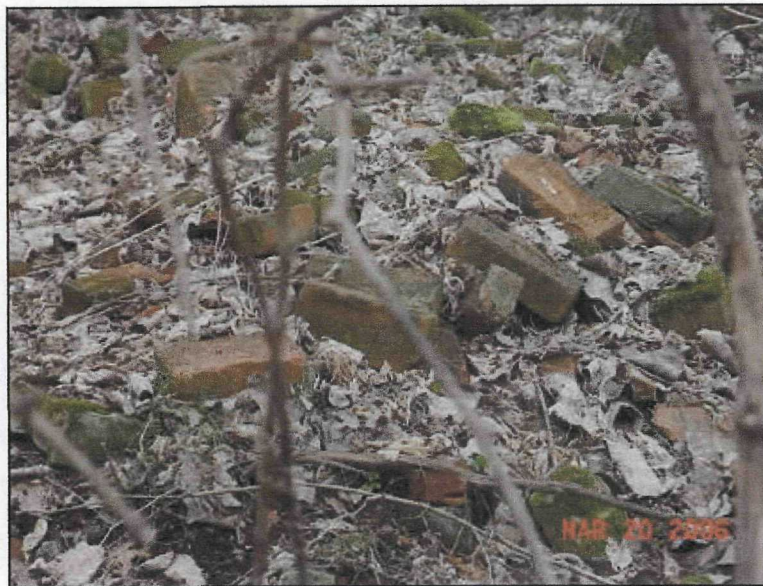
Photograph No. 3 **Date:** March 20, 2006
TDD No.: S05-0603-003 **Orientation:** Down
Location: Lot 5199 Brooklyn Avenue, Sidney, Ohio
Subject: Bricks dumped on the property

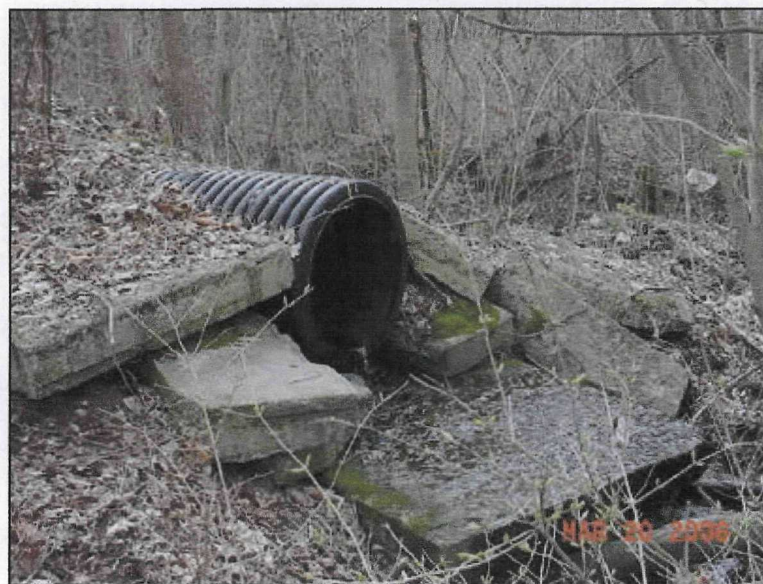
Photograph No. 4 **Date:** March 20, 2006
TDD No.: S05-0603-003 **Orientation:** Southeast
Location: Lot 5199 Brooklyn Avenue, Sidney, Ohio
Subject: Outfall of stormwater drain from Brooklyn Avenue

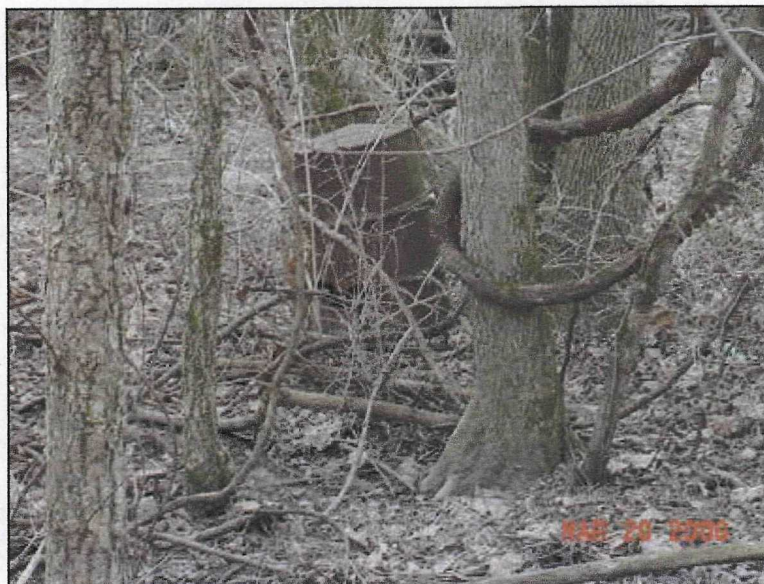
Photograph No. 5 **Date:** March 20, 2006
TDD No.: S05-0603-003 **Orientation:** Southwest
Location: Lot 5199 Brooklyn Avenue, Sidney, Ohio
Subject: Drum in the woods

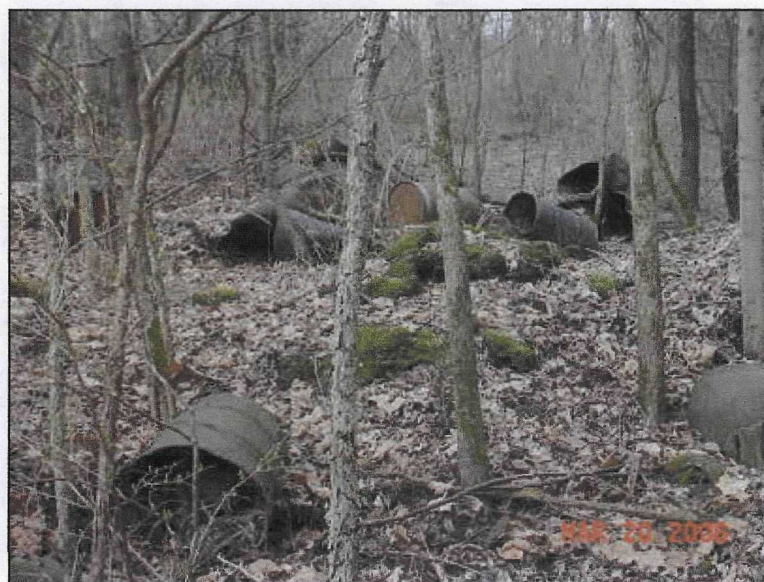
Photograph No. 6 **Date:** March 20, 2006
TDD No.: S05-0603-003 **Orientation:** West
Location: Lot 5199 Brooklyn Avenue, Sidney, Ohio
Subject: Drums in the woods

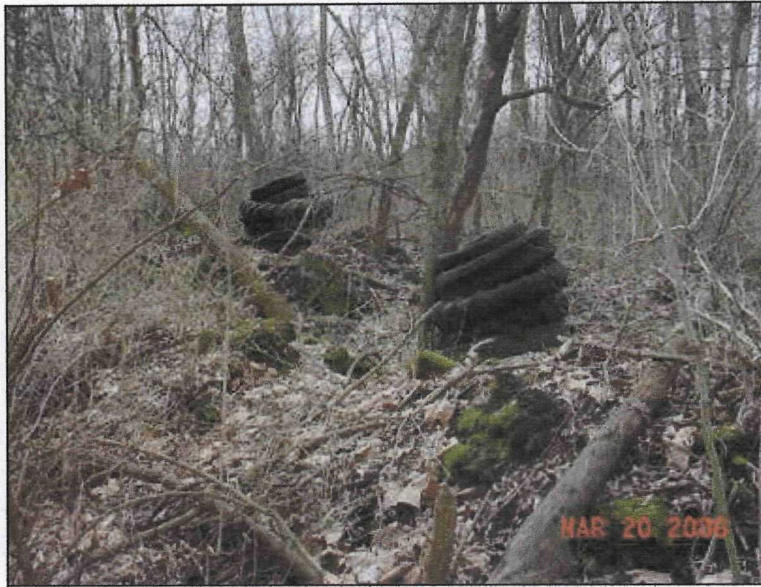
Photograph No. 7 **Date:** March 20, 2006
TDD No.: S05-0603-003 **Orientation:** South
Location: Lot 5199 Brooklyn Avenue, Sidney, Ohio
Subject: Tires in the wooded area

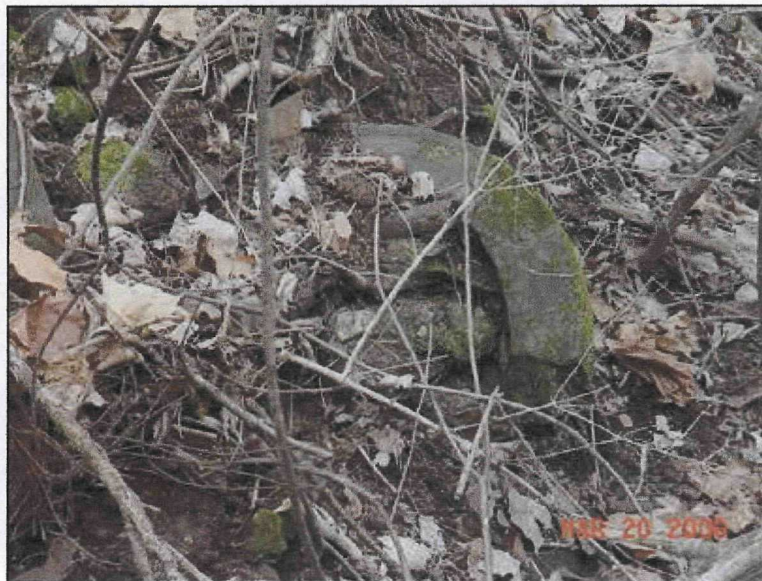
Photograph No. 8 **Date:** March 20, 2006
TDD No.: S05-0603-003 **Orientation:** Down
Location: Lot 5199 Brooklyn Avenue, Sidney, Ohio
Subject: Material coming up through the ground

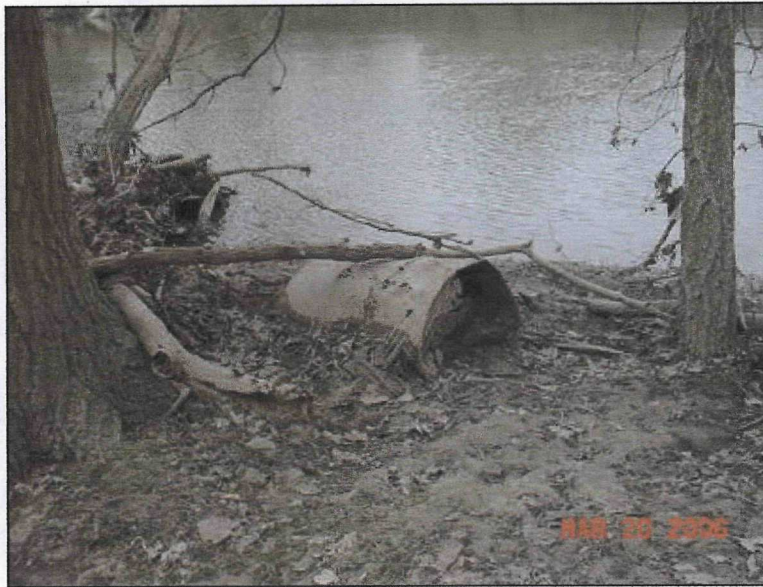
Photograph No. 9 **Date:** March 20, 2006
TDD No.: S05-0603-003 **Orientation:** West
Location: Lot 5199 Brooklyn Avenue, Sidney, Ohio
Subject: Drum located within 5 feet of the Miami River

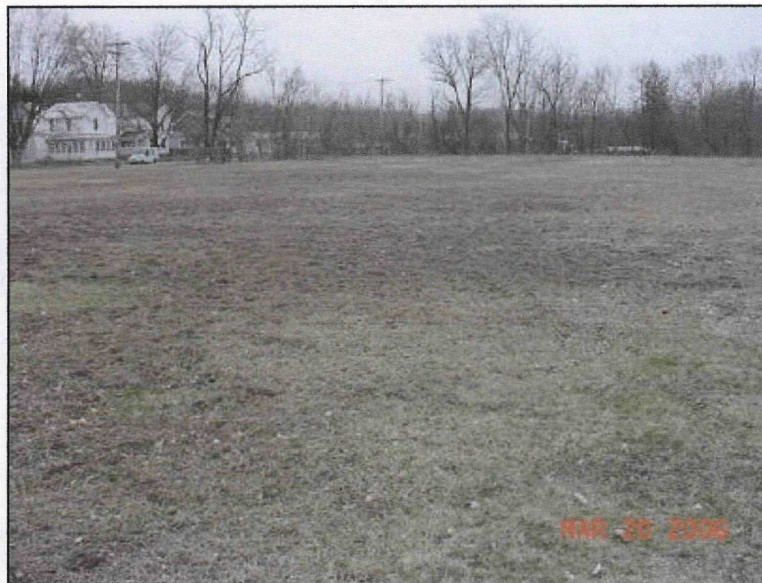
Photograph No. 10 **Date:** March 20, 2006
TDD No.: S05-0603-003 **Orientation:** Southeast
Location: Lot 5199 Brooklyn Avenue, Sidney, Ohio
Subject: Top of the filled area on Brooklyn Avenue. Very little vegetation.

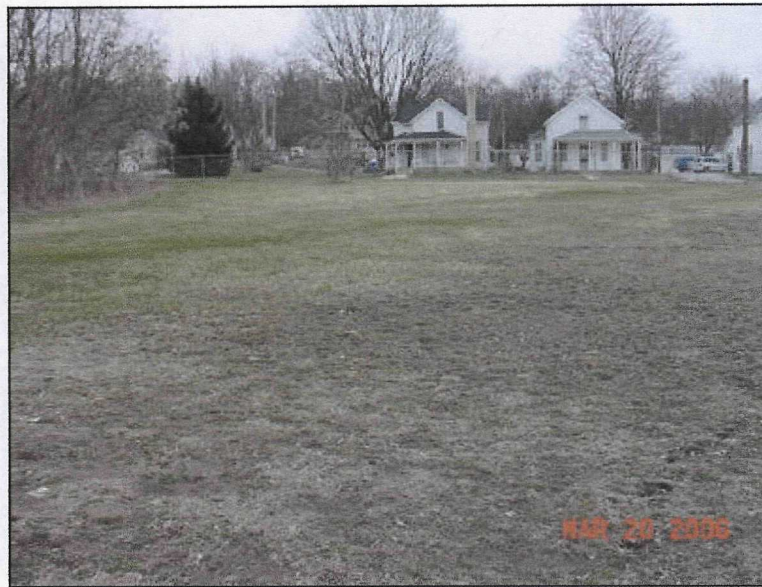
Photograph No. 11 **Date:** March 20, 2006
TDD No.: S05-0603-003 **Orientation:** Northeast
Location: Lot 5199 Brooklyn Avenue, Sidney, Ohio
Subject: Top of the fill area. Stressed little to no vegetation on most of the area.
 Small vegetated portion shown for comparison.

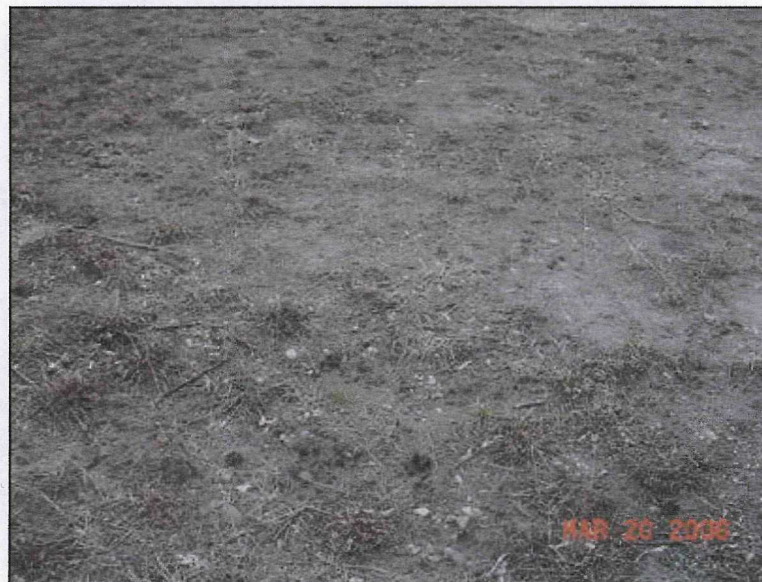
Photograph No. 12 **Date:** March 20, 2006
TDD No.: S05-0603-003 **Orientation:** Down
Location: Lot 5199 Brooklyn Avenue, Sidney, Ohio
Subject: Bare spots upper on fill area.

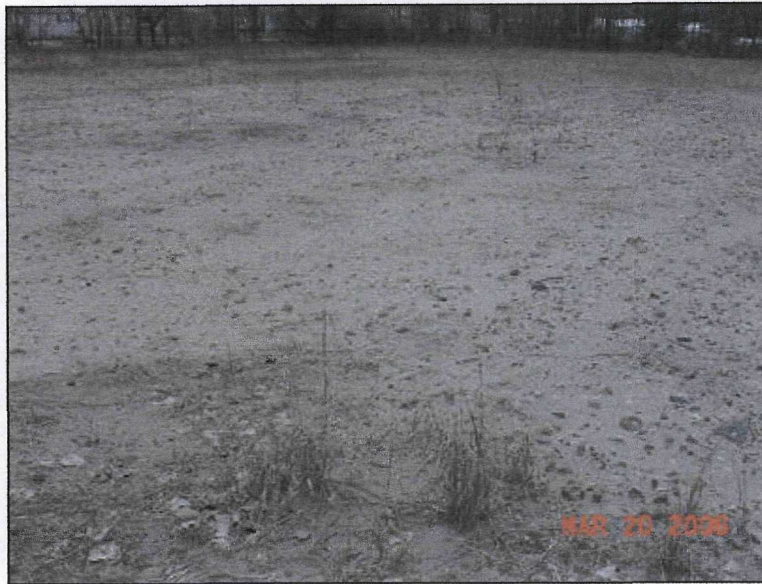
Photograph No. 13 **Date:** March 20, 2006
TDD No.: S05-0603-003 **Orientation:** Southwest
Location: Lot 5199 Brooklyn Avenue, Sidney, Ohio
Subject: Bare area of the upper fill area

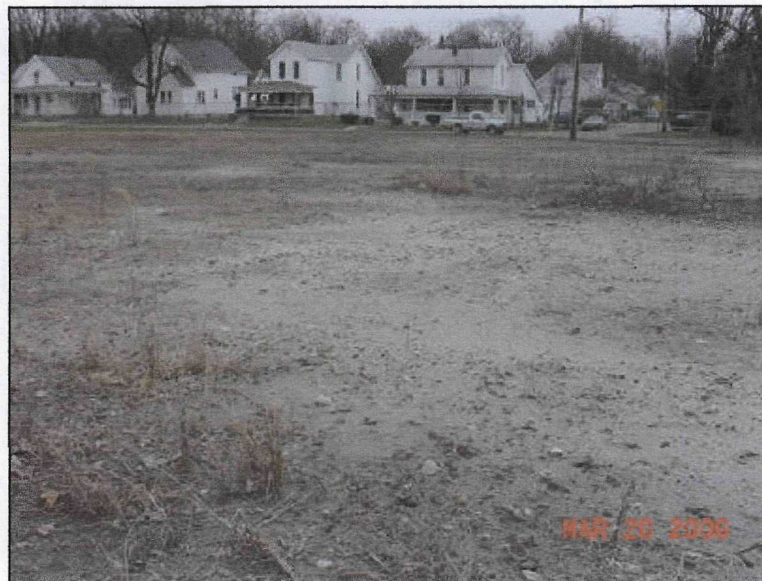
Photograph No. 14 **Date:** March 20, 2006
TDD No.: S05-0603-003 **Orientation:** West
Location: Lot 5199 Brooklyn Avenue, Sidney, Ohio
Subject: Bare area on the upper fill area. Houses are located across the Brooklyn Avenue.

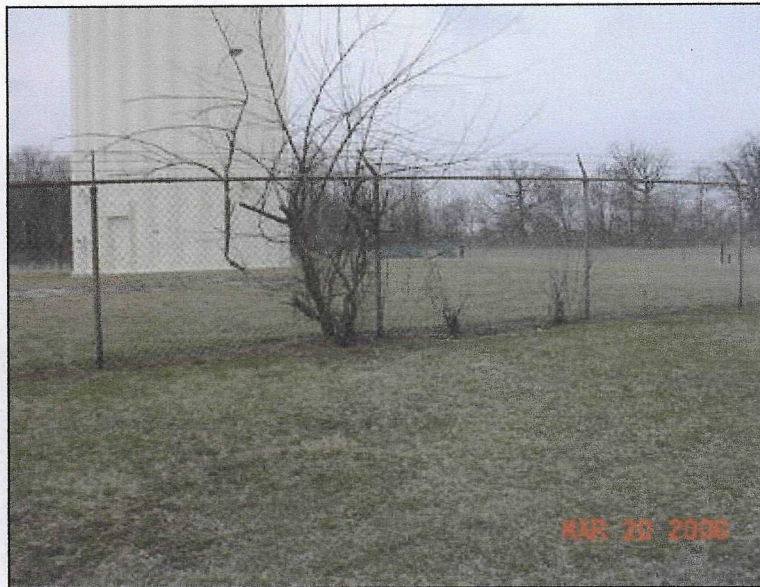
Photograph No. 1 **Date:** March 20, 2006
TDD No.: S05-0603-003 **Orientation:** Northwest
Location: Near 720 S. Edgewood, Urbana, Ohio
Subject: Water tower. City Property is enclosed by fence

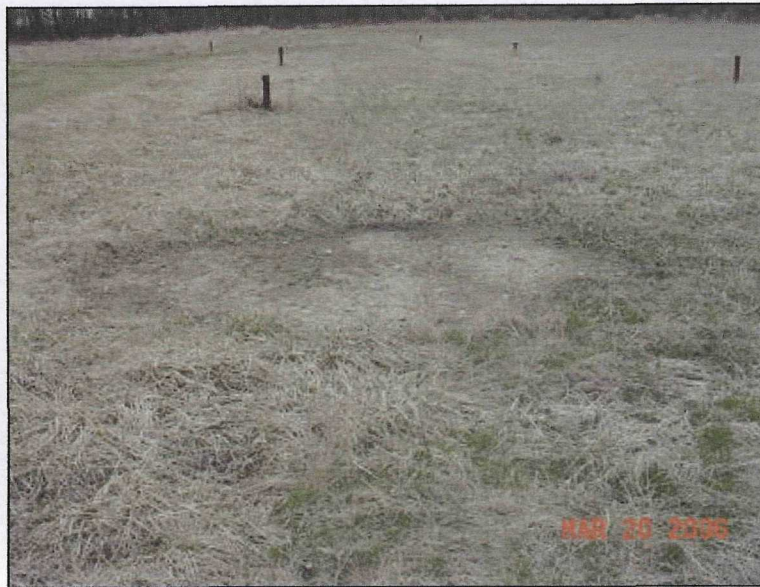
Photograph No. 3 **Date:** March 20, 2006
TDD No.: S05-0603-003 **Orientation:** West
Location: Near 720 S. Edgewood, Urbana, Ohio
Subject: Bare patch of soil

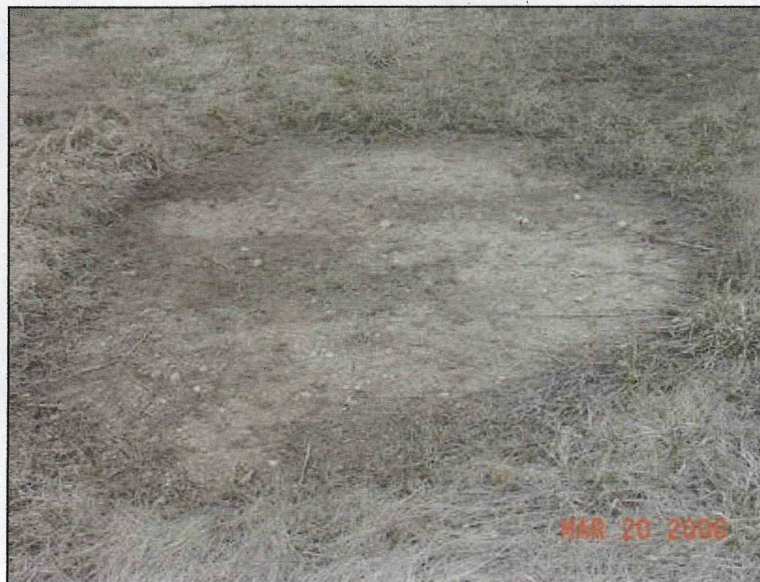
Photograph No. 8 **Date:** March 20, 2006
TDD No.: S05-0603-003 **Orientation:** Down
Location: Near 720 S. Edgewood, Urbana, Ohio
Subject: Close-up of bare soil

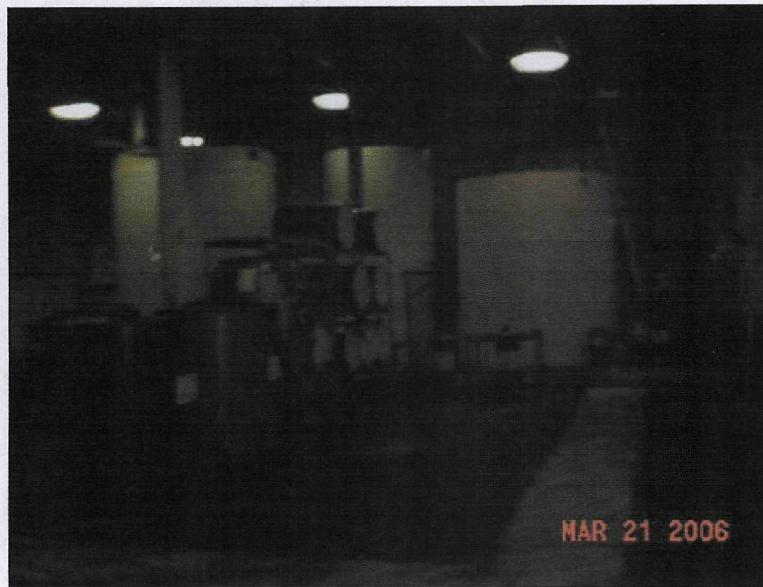
Photograph No. 3 **Date:** March 21, 2006
TDD No.: S05-0603-003 **Orientation:** Inside Building
Location: 215 and 221 Industrial Drive, Hillsdale, Michigan
Subject: Above-ground storage tanks

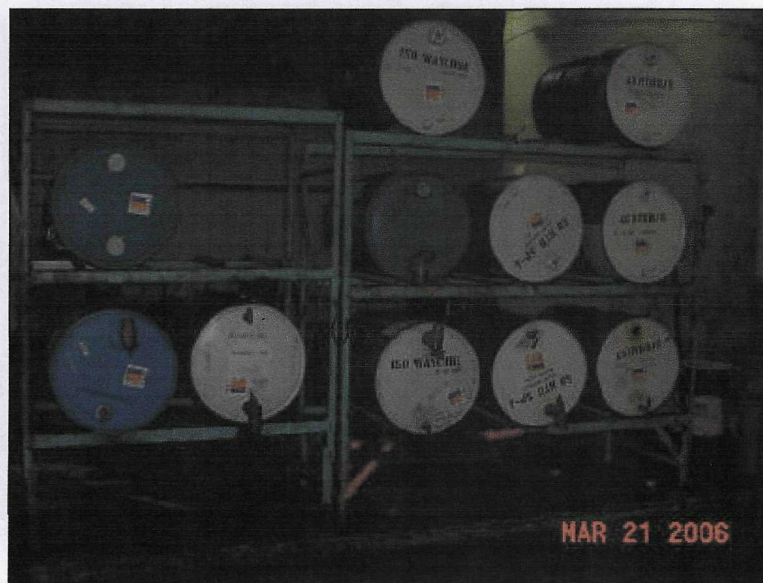
Photograph No. 4 **Date:** March 21, 2006
TDD No.: S05-0603-003 **Orientation:** Inside Building
Location: 215 and 221 Industrial Drive, Hillsdale, Michigan
Subject: Drums containing petroleum product

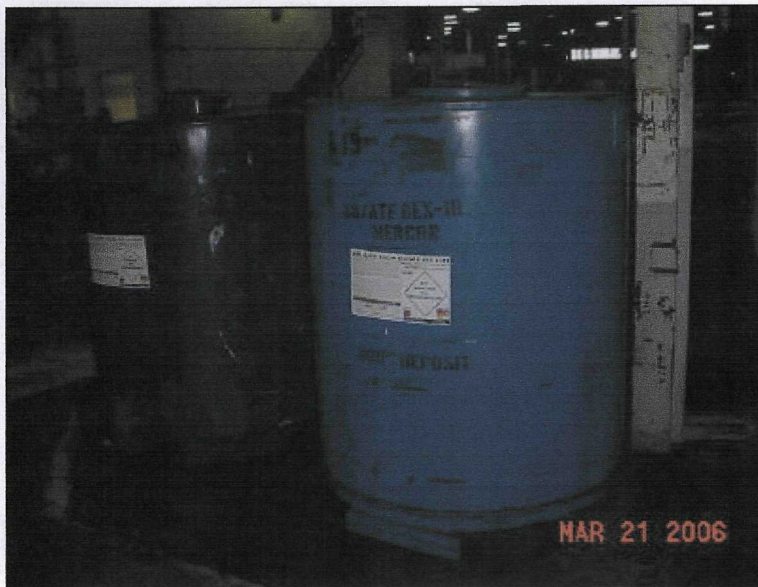
Photograph No. 5 **Date:** March 21, 2006
TDD No.: S05-0603-003 **Orientation:** Inside Building
Location: 215 and 221 Industrial Drive, Hillsdale, Michigan
Subject: Large, petroleum storage containers

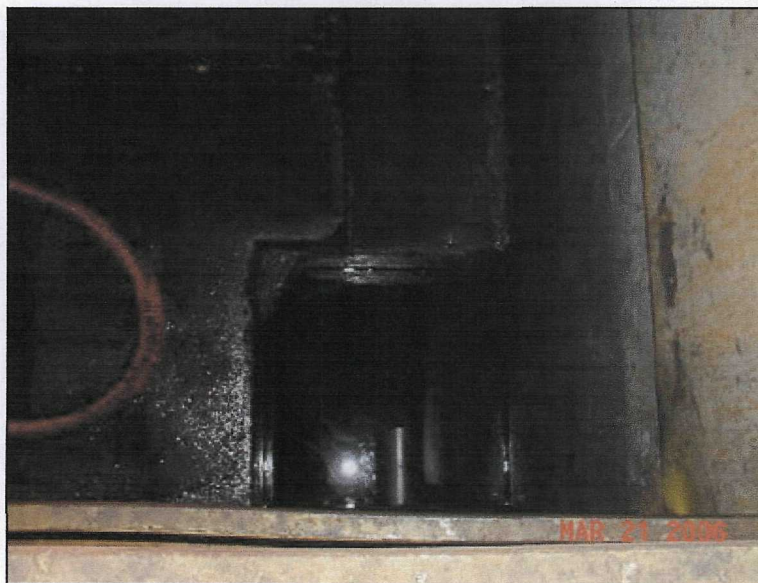
Photograph No. 6 **Date:** March 21, 2006
TDD No.: S05-0603-003 **Orientation:** Inside Building, down
Location: 215 and 221 Industrial Drive, Hillsdale, Michigan
Subject: Visible oil in a sump

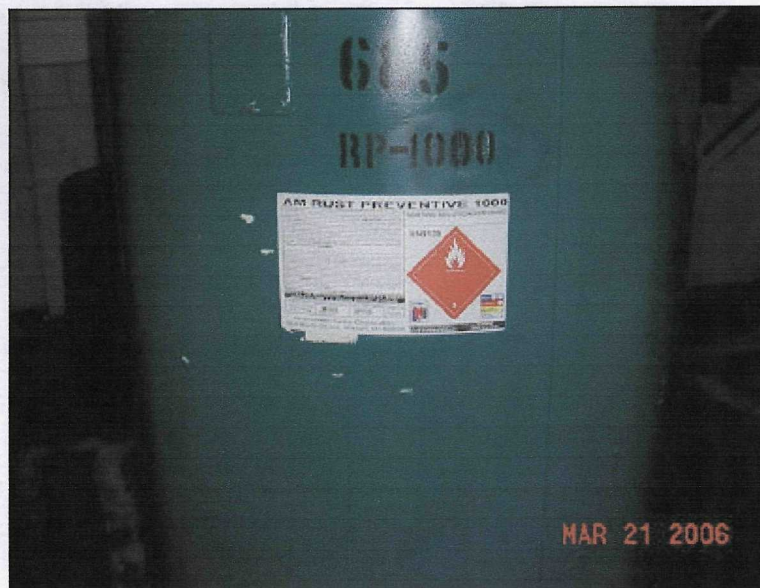
Photograph No. 7 **Date:** March 21, 2006
TDD No.: S05-0603-003 **Orientation:** Inside Building
Location: 215 and 221 Industrial Drive, Hillsdale, Michigan
Subject: Large liquid storage container with flammable sticker
